NorthEast Area Study

Railroad Crossing Study | Summary Report | January 2014

A technical report that identifies railroad / roadway crossing issues and suggested treatments in the Knightdale / Wendell / Zebulon railway corridor

Railroad Crossings Report

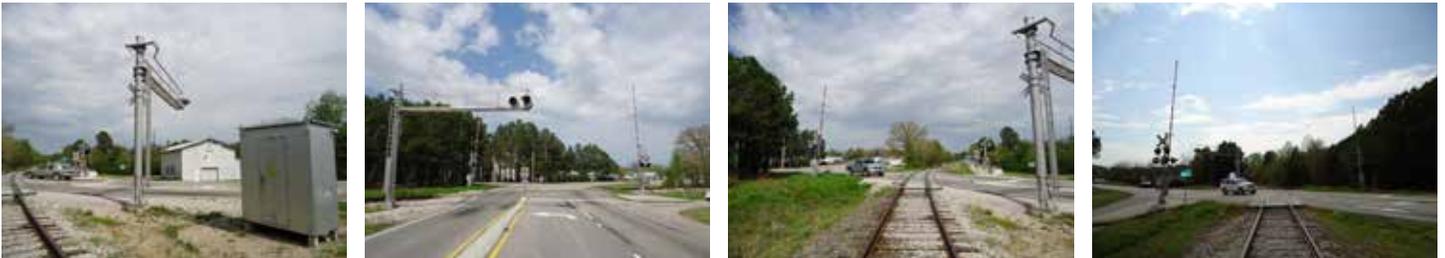
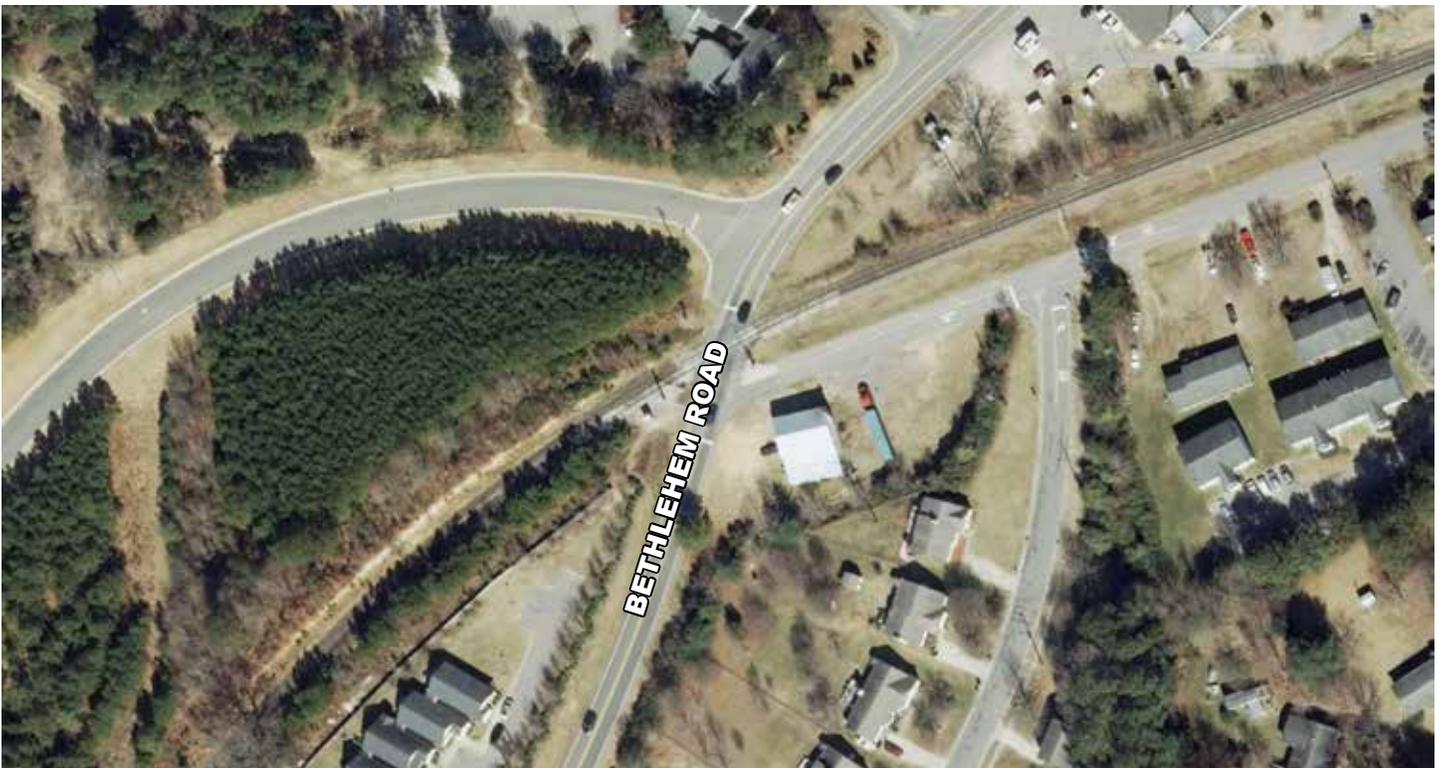
Bethlehem Road/First Street

- West edge of downtown Knightdale
- Between Crosstie Street and Railroad Street
- Main connection to and from the southwest portion of Downtown Knightdale – major connection to Smithfield Road, Poole Road, and points south of Downtown

- Bit of a hump - Flat crossing is best for Materials
- Roadway was recently widened with development project north of the track
- Signals/gates/cantilever with signals in both directions
- Both RR and roadway are in curves
- recently worked – panels on crossing (bolt down to 10'tie)
- 25 mph speed zone
- There is existing sidewalk on the west side of the roadway that does lead to the railroad crossing, but there are no existing pedestrian connections across the tracks.
- Raised island in the center of roadway and for the turn onto Railroad Street – painted to be seen
- 2011 ADT: 6,700 vpd, high volume of school bus crossings

- A good example of a safe, high volume crossing
- Needs to have better approach signage and the inclusion of a reduce speed ahead sign in the northbound direction

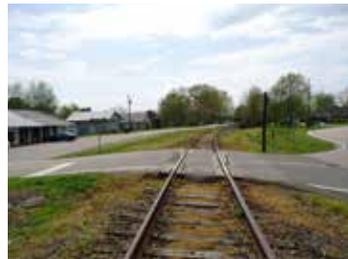
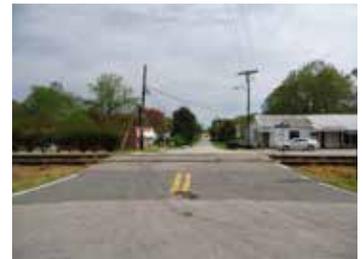
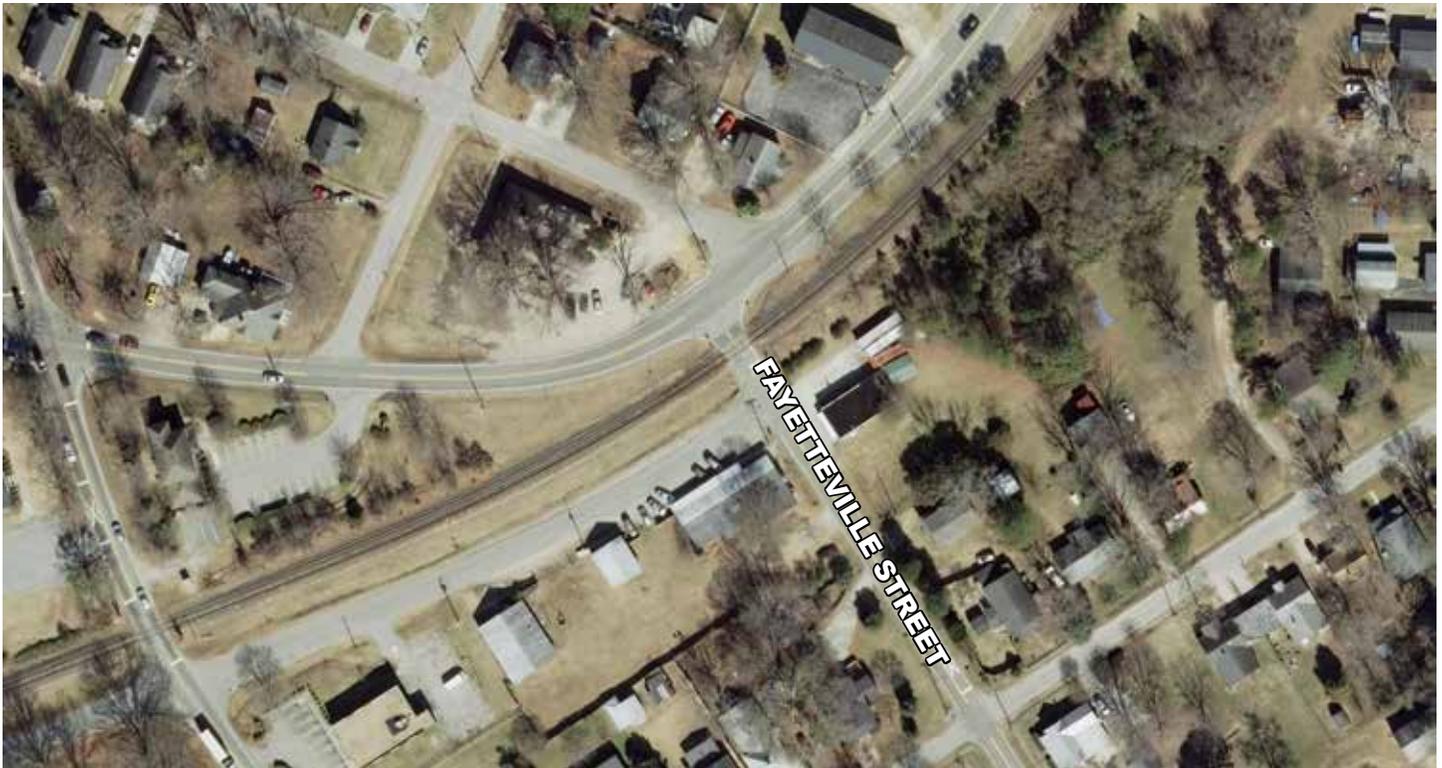
Fayetteville Street

- Humped with a lot of damage to the crossing
- Crossbucks only
- RR track in curve- sight distance concerns
- 25 mph speed zone
- Larger trucks were seen to have avoided this crossing because of the geometric problems
- 2011 ADT: 1,200 vpd, high volume of school bus crossings (near Elementary School)
- Recent accident (last 10 years): car was hit by train while sitting on tracks at the intersection of Fayetteville and First

- This crossing has long been determined as a good crossing to close by both CLNA and NCDOT rail. When the closure was brought to the community, the public was not in agreement.
- Signals and gates should be added to achieve a safer crossing while improving the crossing and signage
- Warning signs with directional arrows on both Railroad Street and First Avenue

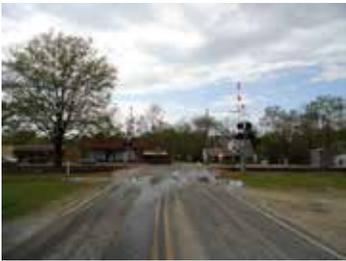
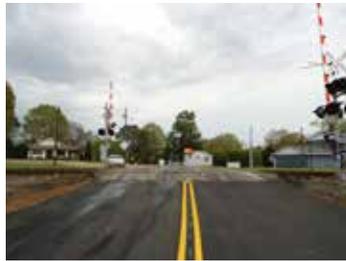
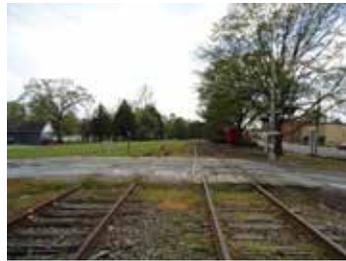
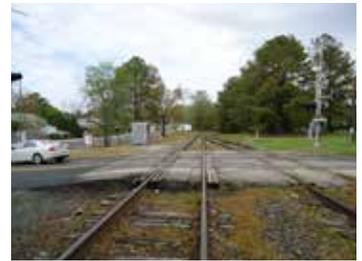
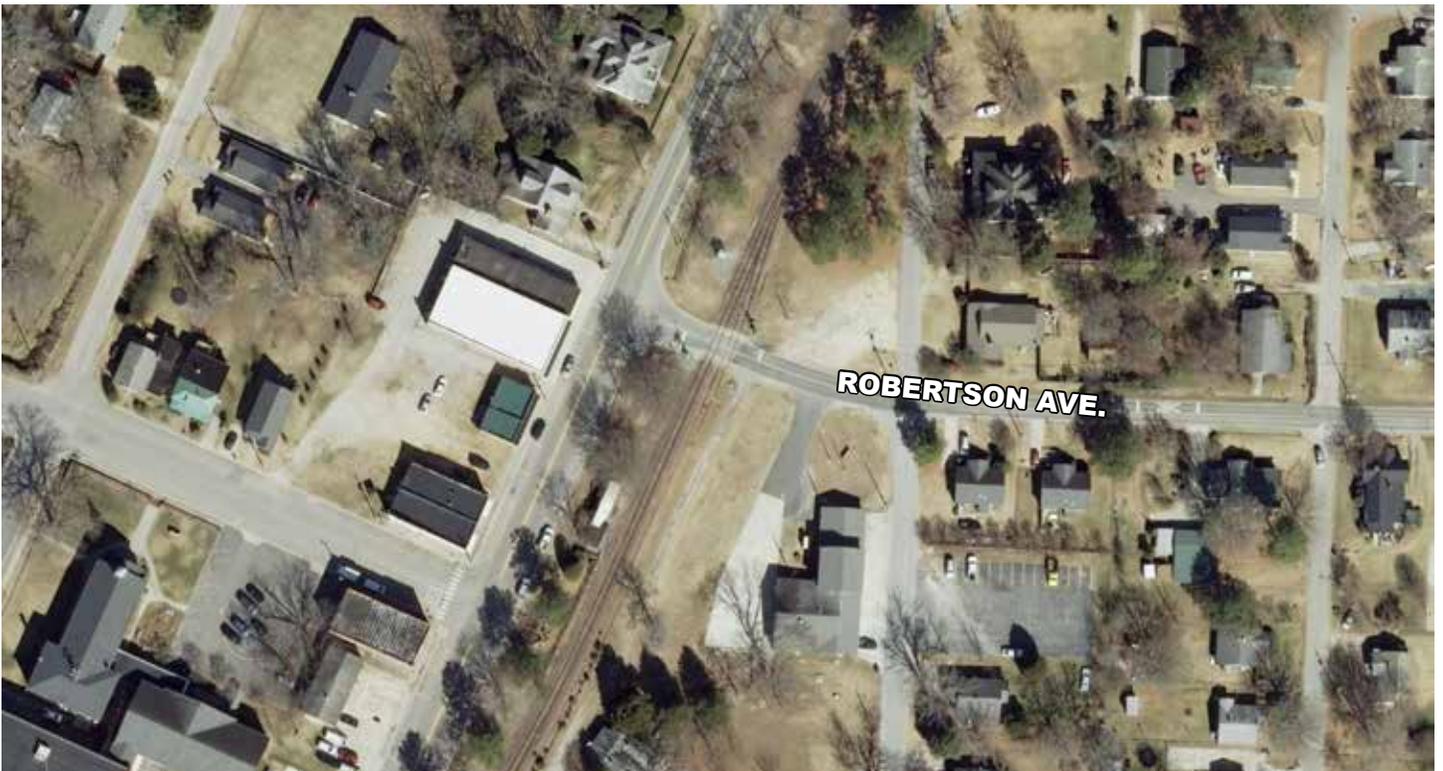
Robertson Ave.**Location:**

- Humped crossing – especially on the First Ave. side
- Perpendicular crossing – good sight distance
- signals/gates – all signals face directions of traffic
- Dual tracks – no improvements to ties on vehicular crossing
- 25 mph speed zone
- Fire truck passed through without hitting bottom
- 2011 ADT: 1,500 vpd
- Does have an accident history (one incident in last 10 years)

- Warning signs with directional arrows on First Avenue

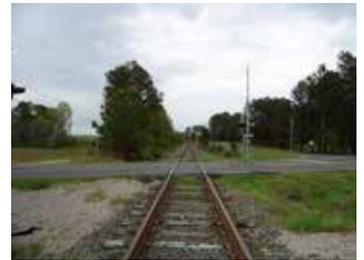
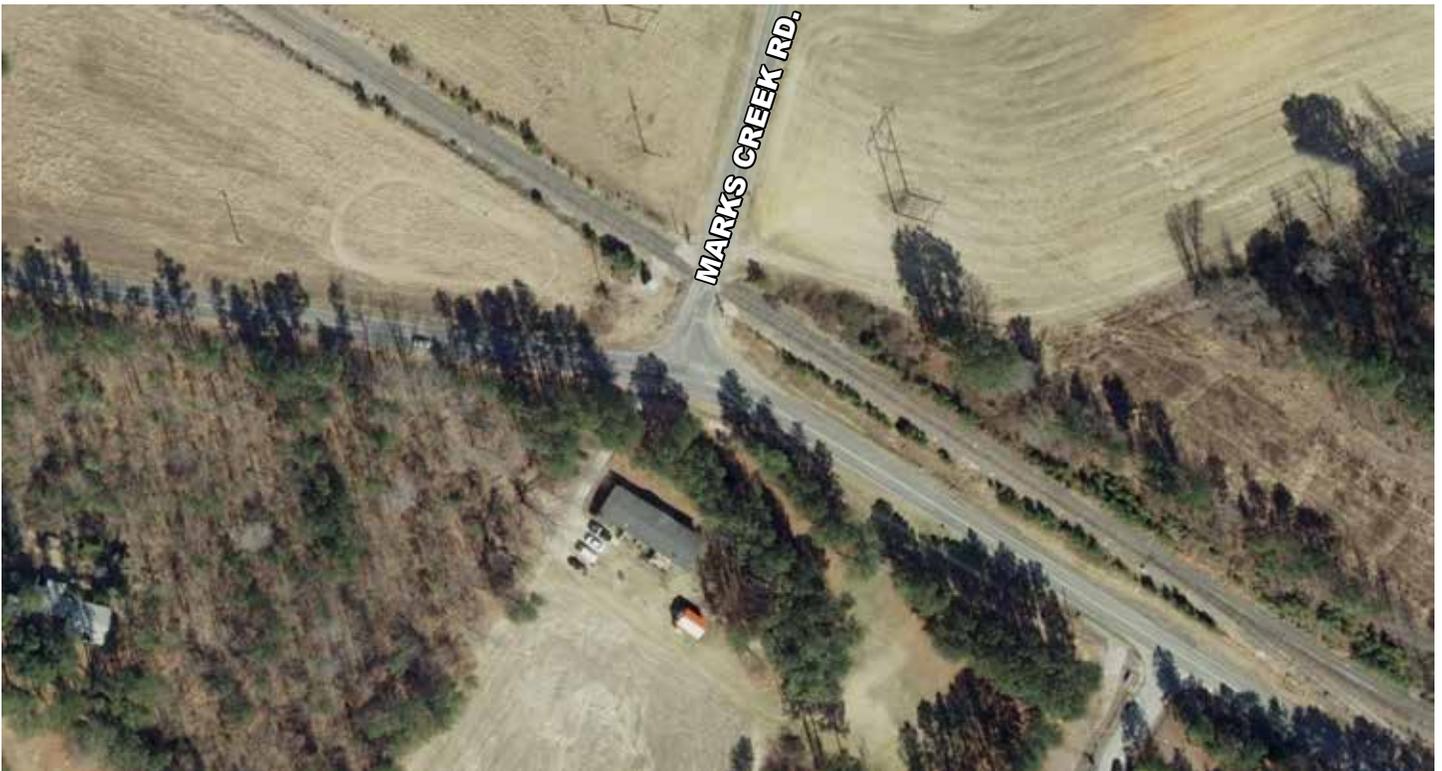
Marks Creek Road

- Very close to the intersection
- Flat and perpendicular crossing – good sight distance
- One track - Asphalt on crossing
- Signals/gates – all signals face directions of traffic at intersection
- No speed zone
- 2011 ADT: under 1,000 vpd, high volume of school bus crossings

- Warning signs with directional arrows on Robertson/Knightdale-Eagle Rock
- A long term treatment could include converting the WB right turn movement to a free flow movement or reducing the curb radius of the approach (intersection clean-up using curb and gutter for the radii on the Marks Creek approach)

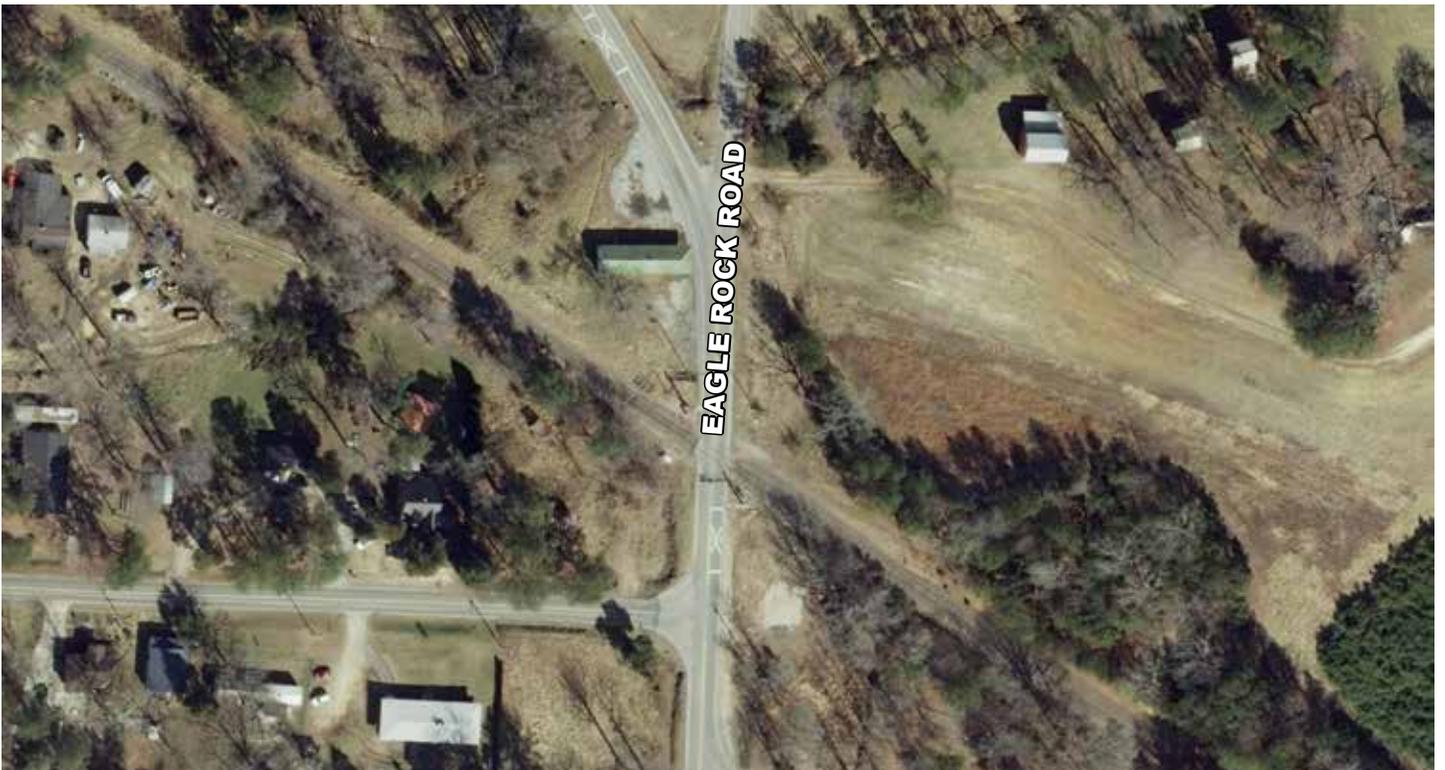
Eagle Rock Road

- One track – angled crossing – sight distance concern from the north
- Multiple roadways with multiple intersections near the crossing
- Signals/gates/cantilever with signals in both directions
- 55 mph speed zone
- 2011 ADT: 3,800 vpd

- Better warning signage with directional arrows on both main roadway and on crossing roadways on both sides of the track

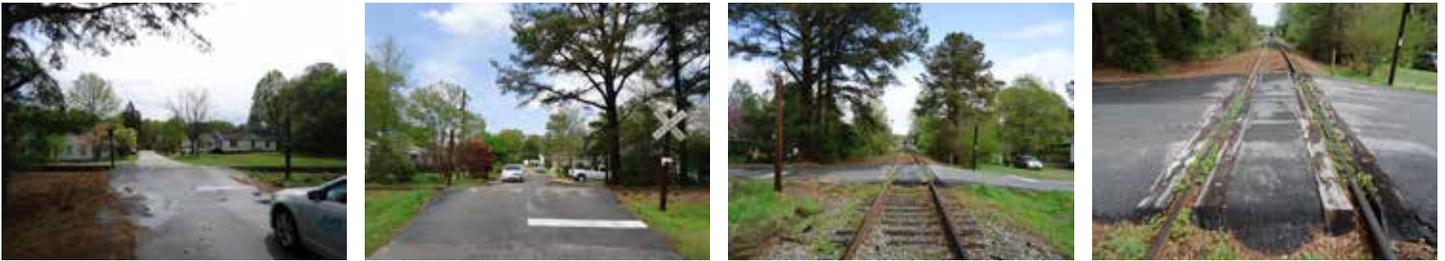
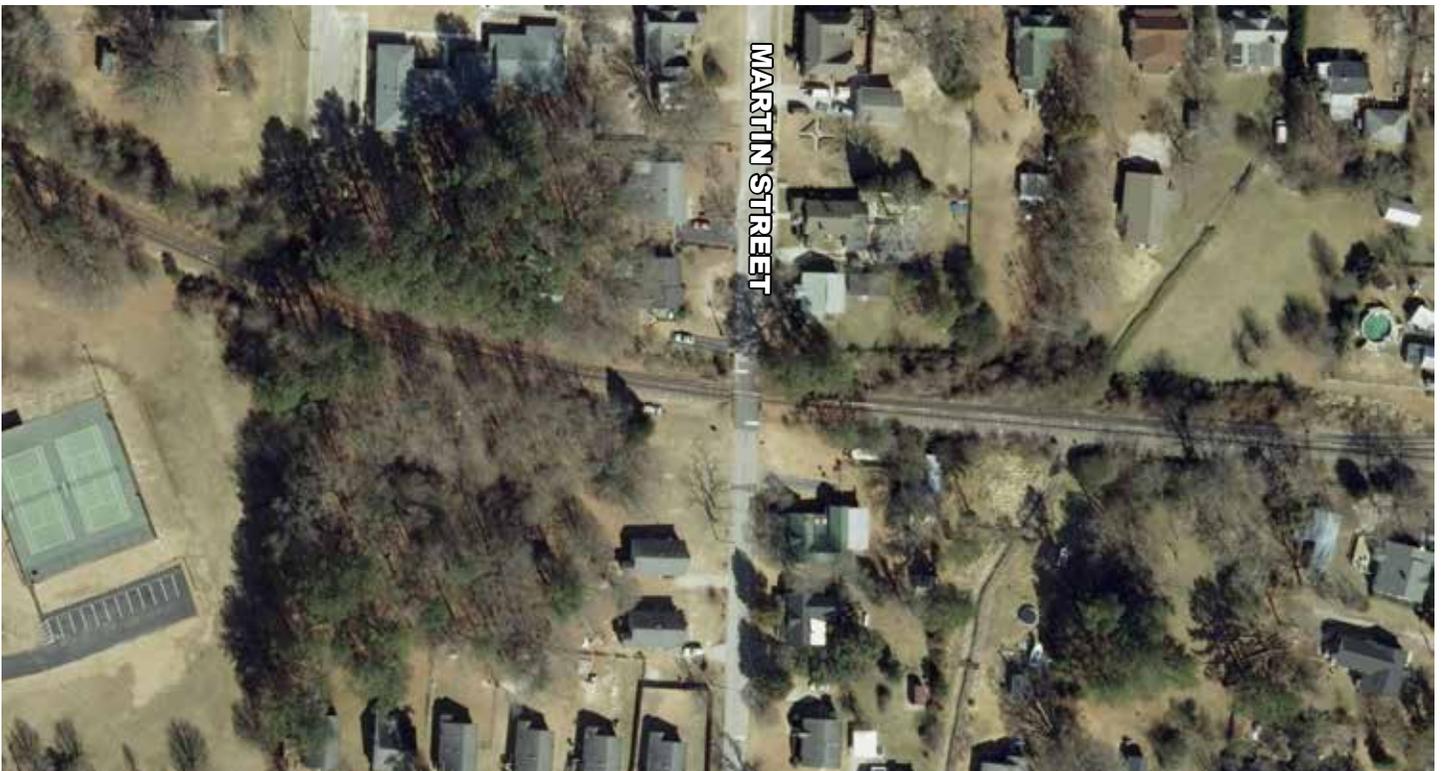
Martin Street

- Humped crossing
- One track – asphalt covering crossing
- Only has crossbucks
- Used by school buses
- Small residential road with low volumes

- No recommendations at this time - Crossing will be monitored into future for usage.

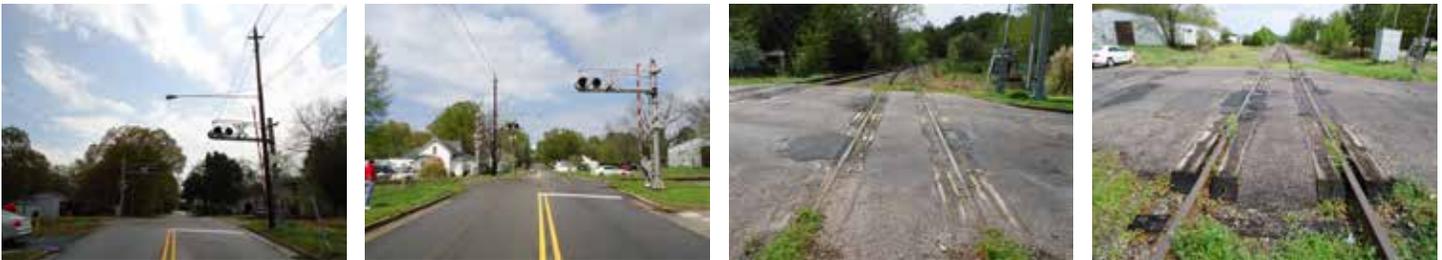
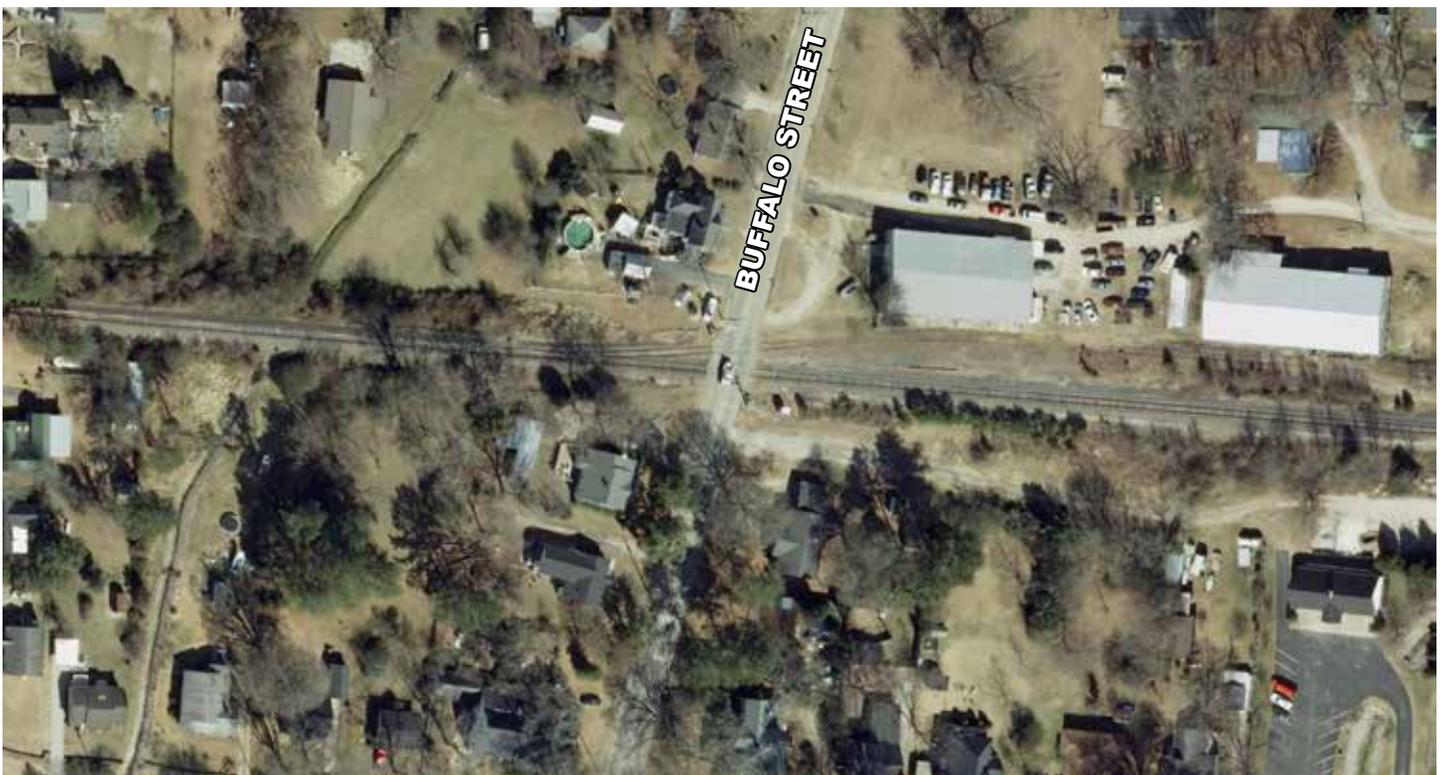
Buffalo Street

- Two tracks – perpendicular- good sight distance
- Hump in roadway – asphalt filled crossing with wood protecting the rail
- Signals/gates/cantilever with signals in both directions
- 35 mph speed zone
- The sidewalk stops/starts approximately 100 feet on both sides of the tracks
- There is cable and gas located under the crossing
- 2011 ADT: 2,800 vpd, high volume of school bus crossings

- Volumes may increase with the opening of Wendell Falls Parkway. The current configuration is safe for higher volumes.
- The sidewalk should be continued through the crossing for a safer pedestrian connection. The sidewalk should be included within the fall of the gates to ensure maximum protection for all users.
- Delineate the edge of the travelway to help separate the vehicular traffic and the pedestrian traffic

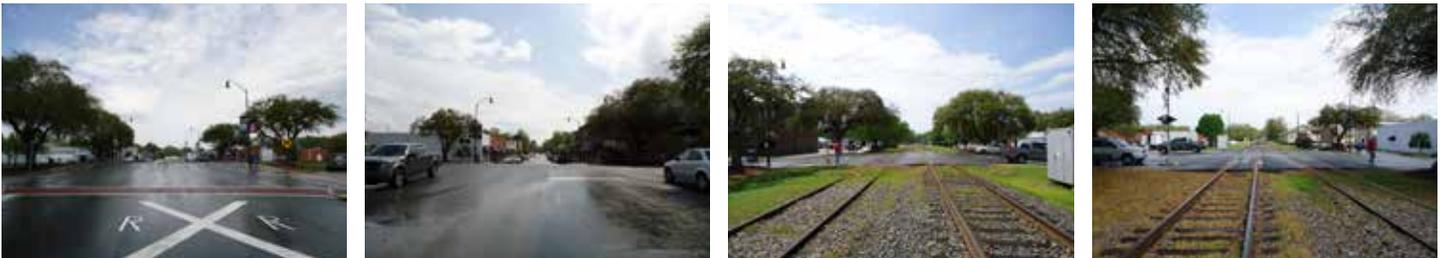
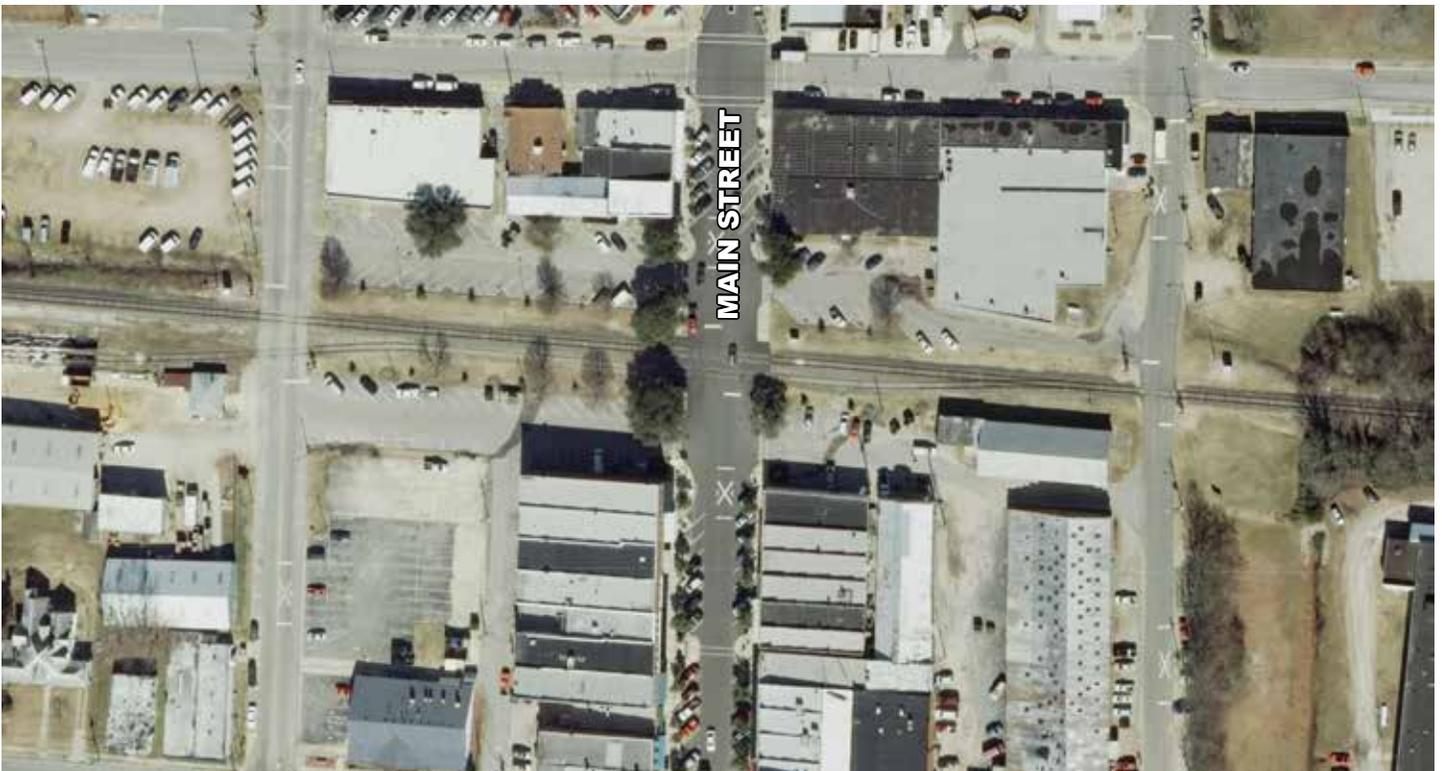
Main Street

- Two tracks – perpendicular- good sight distance
- Hump in roadway – asphalt filled crossing with wood protecting the rail – paved recently
- Signals/crossbucks in both directions
- Road is very wide
- 20 mph speed zone
- Sidewalk on both sides of the roadway stops/starts at crossing on both sides of the tracks
- Both parallel streets (Pine and Cypress) have gates (narrower crossings)
- 2011 ADT: 2,700 vpd, low volume of school bus crossings

- Pedestrian movements are extremely important through this crossing. Gates not only need to be installed to make the vehicular crossing safer, they should be added for the pedestrian movements as well.
- The roadway may need to be narrowed to make the installation of the gates more cost effective
- Crossing also needs better warning signage – difficult to place on a wide street
- Consider the installation of Quad Gates that will control the crossing for both the vehicular traffic and pedestrian traffic

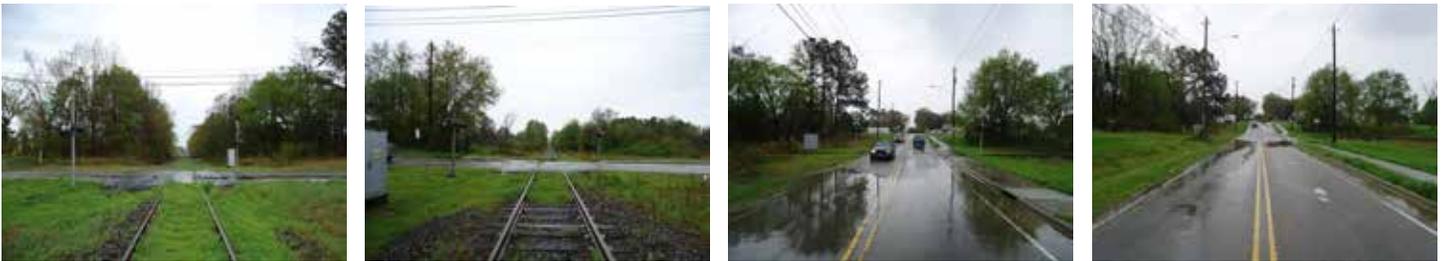
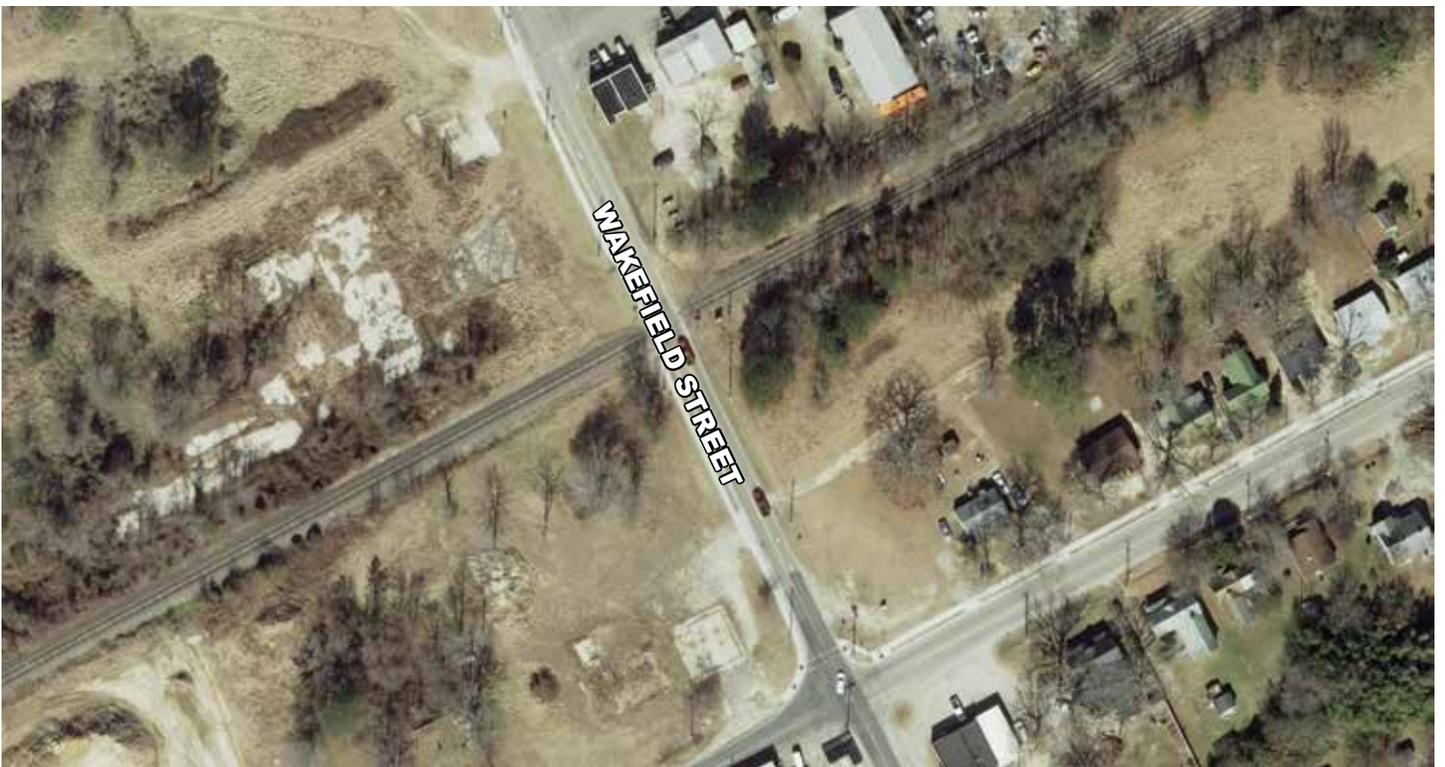
Wakefield Street

- 1 track
- Signal, Crossbucks
- No Gates
- Low point in roadway – possible flooding
- Asphalt from RR fills the roadway and extends to sidewalk
- Sidewalk connection dies at RR crossing
- Panels are extra wide for bikes, pedestrians
- 35 mph speed limit
- Regular warning signs – standard round signs
- 2011 ADT: 3,300 vpd, high volume of school bus crossings

- Crossing is substantial enough to warrant gates
- Pedestrian connections are extremely important, connect sidewalk through track area, protect movements with separate gate facilities – NCLA RR has dictated that pedestrian movements need to be protected equally with vehicular movements
- Future study for flooding – determine how to remove flooding condition

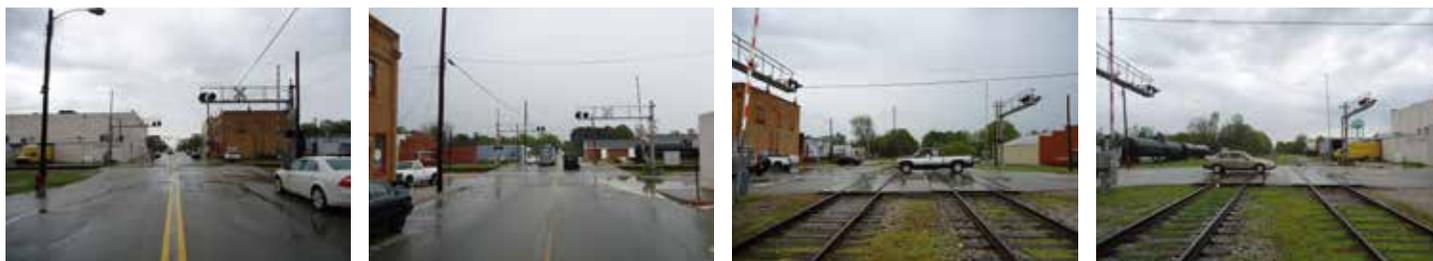
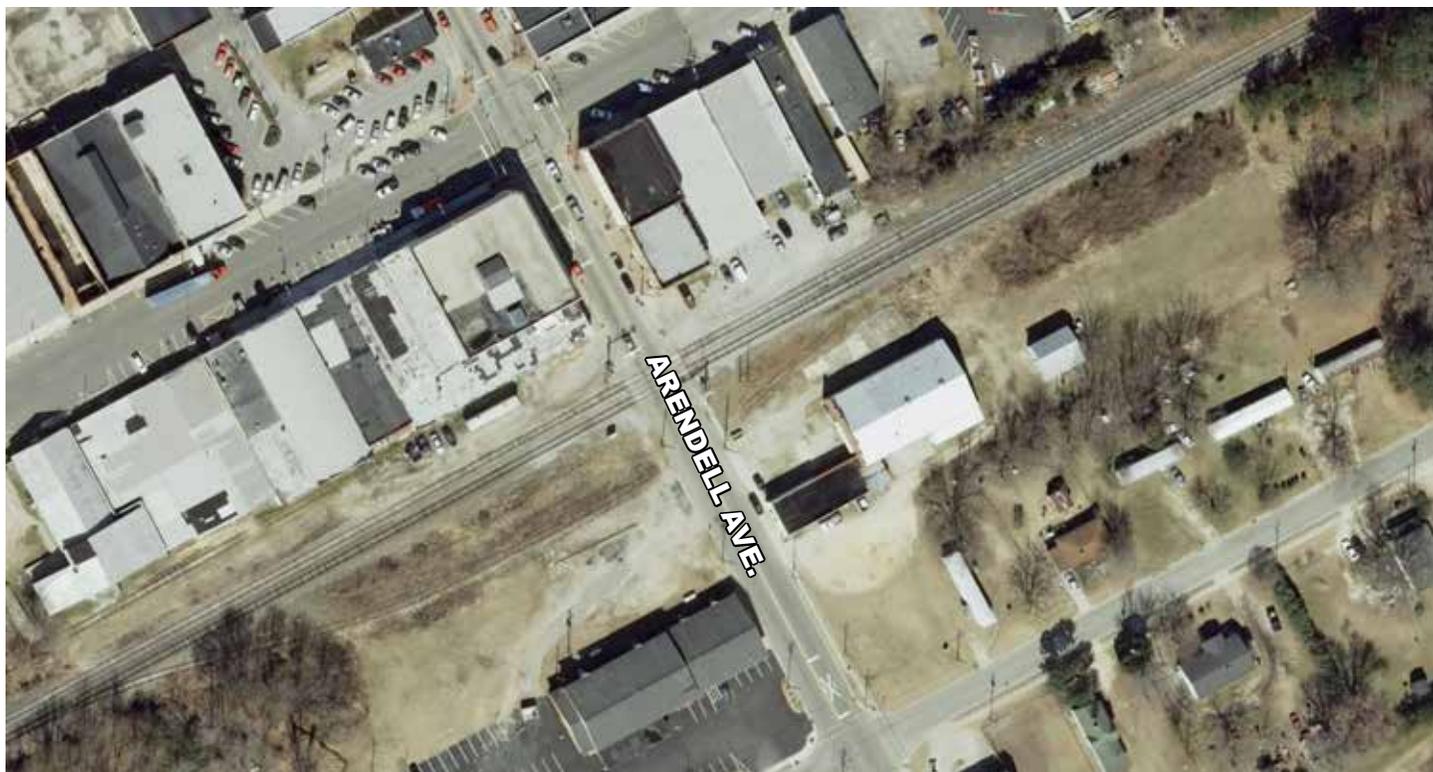
Arendell Ave. - NC 96**Location:**

- 2 tracks
- Cantilevers, Overhead Signal, Bucks
- Gate Signals
- Panel in road over hump
- Sidewalks on both sides stop at tracks
- Panels are extra wide for bikes, pedestrians
- 20mph speed limit
- Warning signs – standard round signs
- 2011 ADT: 5,000 vpd, high volume of school bus crossings

- Pedestrian connections are extremely important, connect sidewalks through track area, protect movements with separate gate facilities – NCLA RR has dictated that pedestrian movements need to be protected equally with vehicular movements
- In the short term, delineate the edge of the travelway to clearly differentiate vehicular traffic from pedestrian traffic
- Install appropriate pavement markings

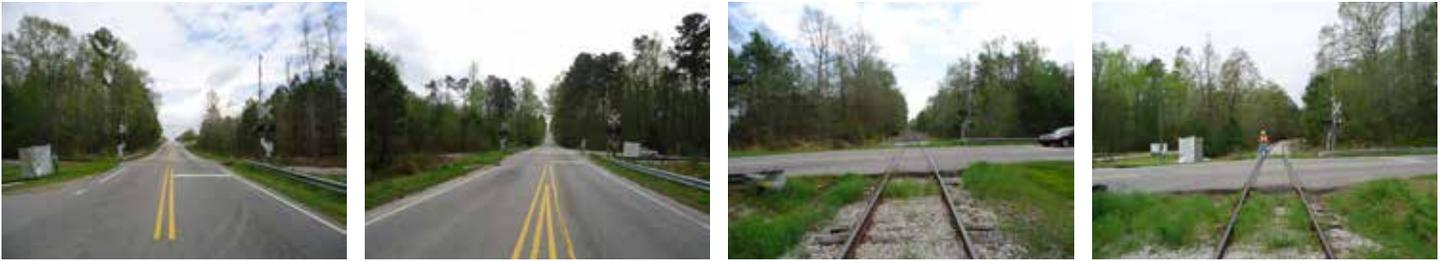
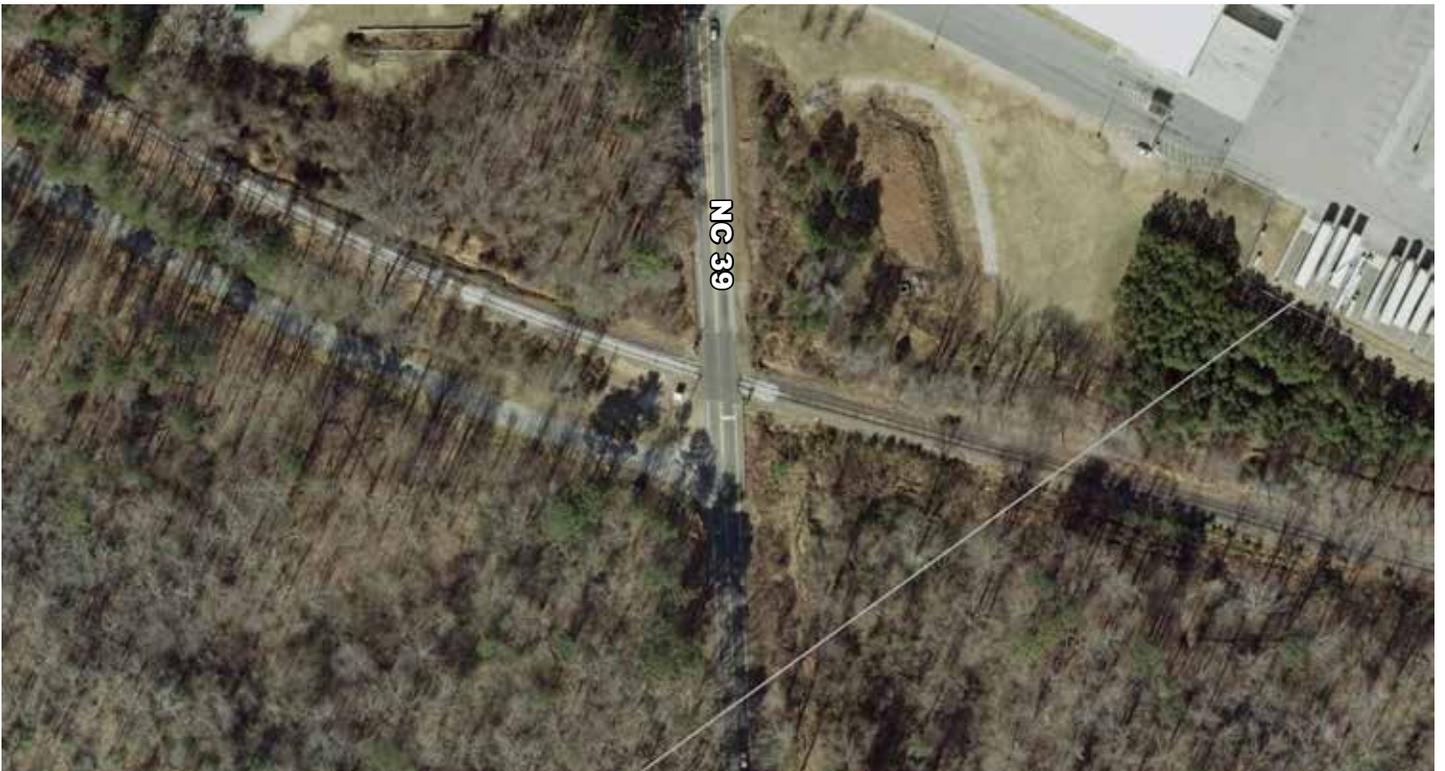
- Stream Next to Tracks
- Gates, Lights, Crossbucks
- Guardrail protection both directions
- Warning Signs
- No Speed limit posted – 55mph
- Asphalt to Rail / some cracking, conditions ok
- rubberized curbing protecting rail
- 2011 ADT: 4,700 vpd

- Improve warning signs - replace with high intensity signage per MUTCD
- Lower speed of vehicles – possible speed limit decrease to 45 mph
- Install rumble strips on NC 39 to alert drivers and lower speeds
- Install warning flashers to be activated for advanced warning of an approaching train
